Trials on F/V Sea Mac
To Evaluate the Use of Electronic
Monitoring for the Kodiak, AK Rockfish
Pilot Program

January 2008

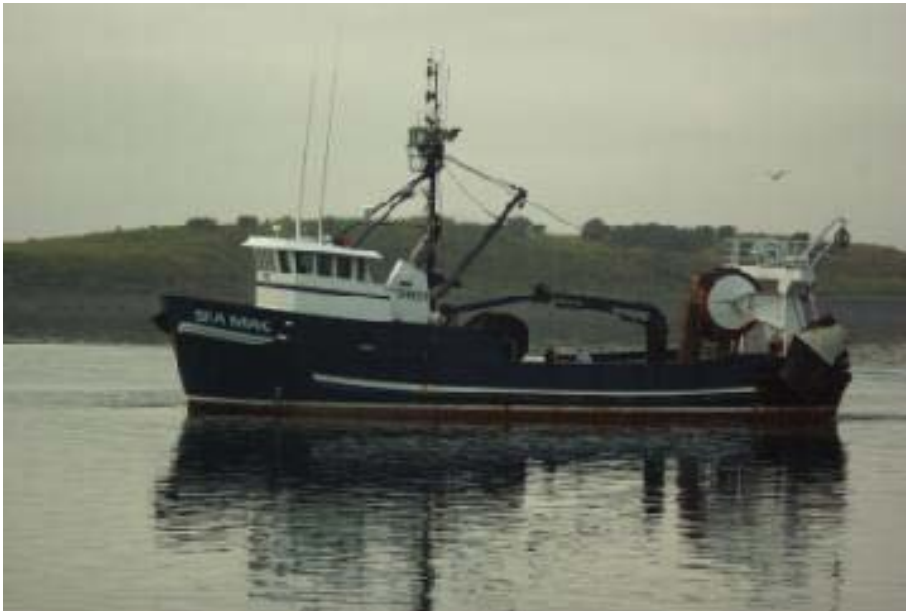
Figure 1. Photograph of F/V *Sea Mac*.

AGDB obtained an Experimental Fishing Permit to charter the commercial fishing vessel *F/V Sea Mac* (Figure 1) to carry out rockfish fishing for about a four - week period in the fall of 2007, making 6 trips and 27 tows. The vessel was required to retain onboard all catch except halibut, under simulated conditions of the RPP. Observers were to carry out the standard basket sampling method for each tow to assess halibut catch. In addition, halibut were whole-haul sorted from each tow, counted and measured. Prior to measuring, halibut were passed across a 'pre-discard chute', simulating the discarding that would occur under the RPP. The pre-discard chute was graduated with 5cm marks to enable camera-based measurements of 'discarded' halibut.

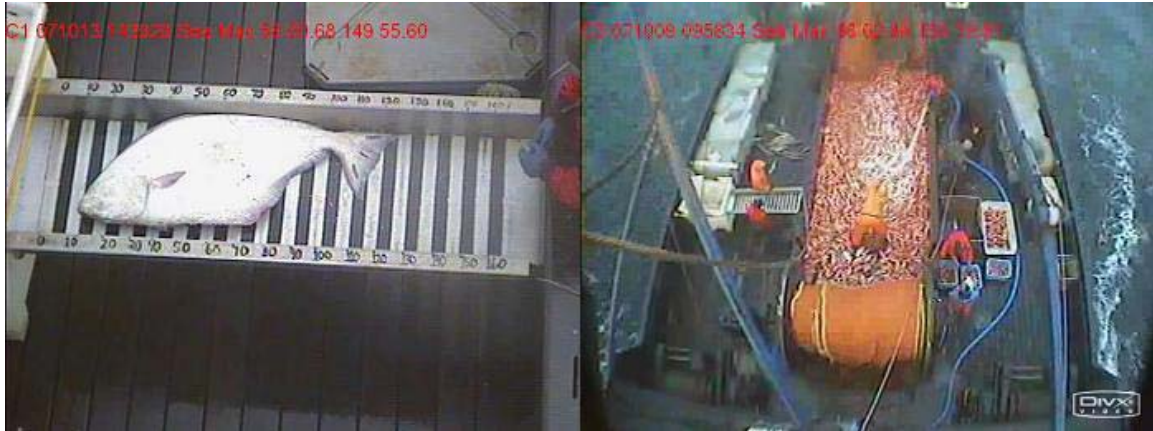
Figure 1. EM camera views from F/V *Sea Mac* showing pre-discard chute and fishing deck.

1. Measurement of lengths of halibut on pre-discard chute - EM viewers reviewed imagery from catch stowage operations of all fishing events to enumerate and measure halibut passing across the pre-discard chute (Figure 2). Fish lengths were determined by measuring the fish in millimetres and scaling this measurement to the reference provided by the 5cm graduation marks on the pre-discard chute. All halibut were measured by fork length. Two independent viewers examined all fishing events.

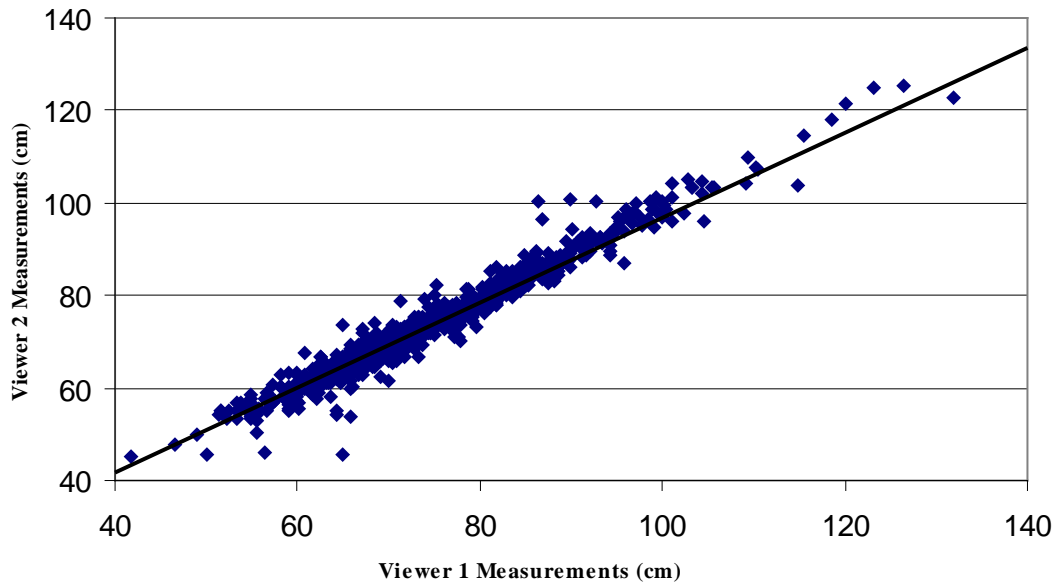
Figure 3. Scatter Plot showing the relationship between two image analysis viewers for measurements of halibut.

Halibut size measurements were compared between the two viewers and were found to be very consistent across the full size range of halibut encountered. These results are shown in Figure 3 comparing the two EM viewer data sets.

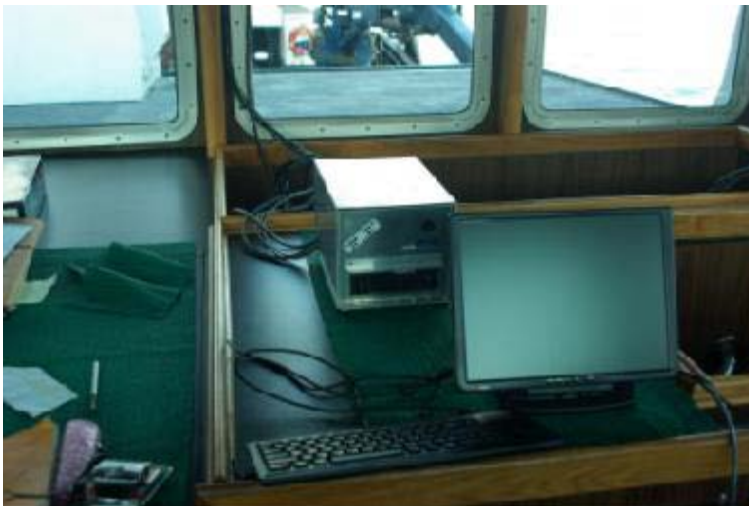
Figure A1. EM control box and user interface installation.

The heart of the electronic monitoring system is a metal tamper-resistant control box (approx. 15x10x8" = 0.7 cubic feet) that houses computer circuitry and data storage devices. The control box receives inputs from several sensors and up to four CCTV cameras. The control box is generally mounted in the vessel cabin and powered with either DC or AC electrical power. In the case of AC power, the control box may be also fitted with a UPS, to ensure continuous power supply. The user interface provides live images of camera views as well as other information such as sensor data and EM system operational status. The interface has been designed to enable vessel personnel to monitor system performance.

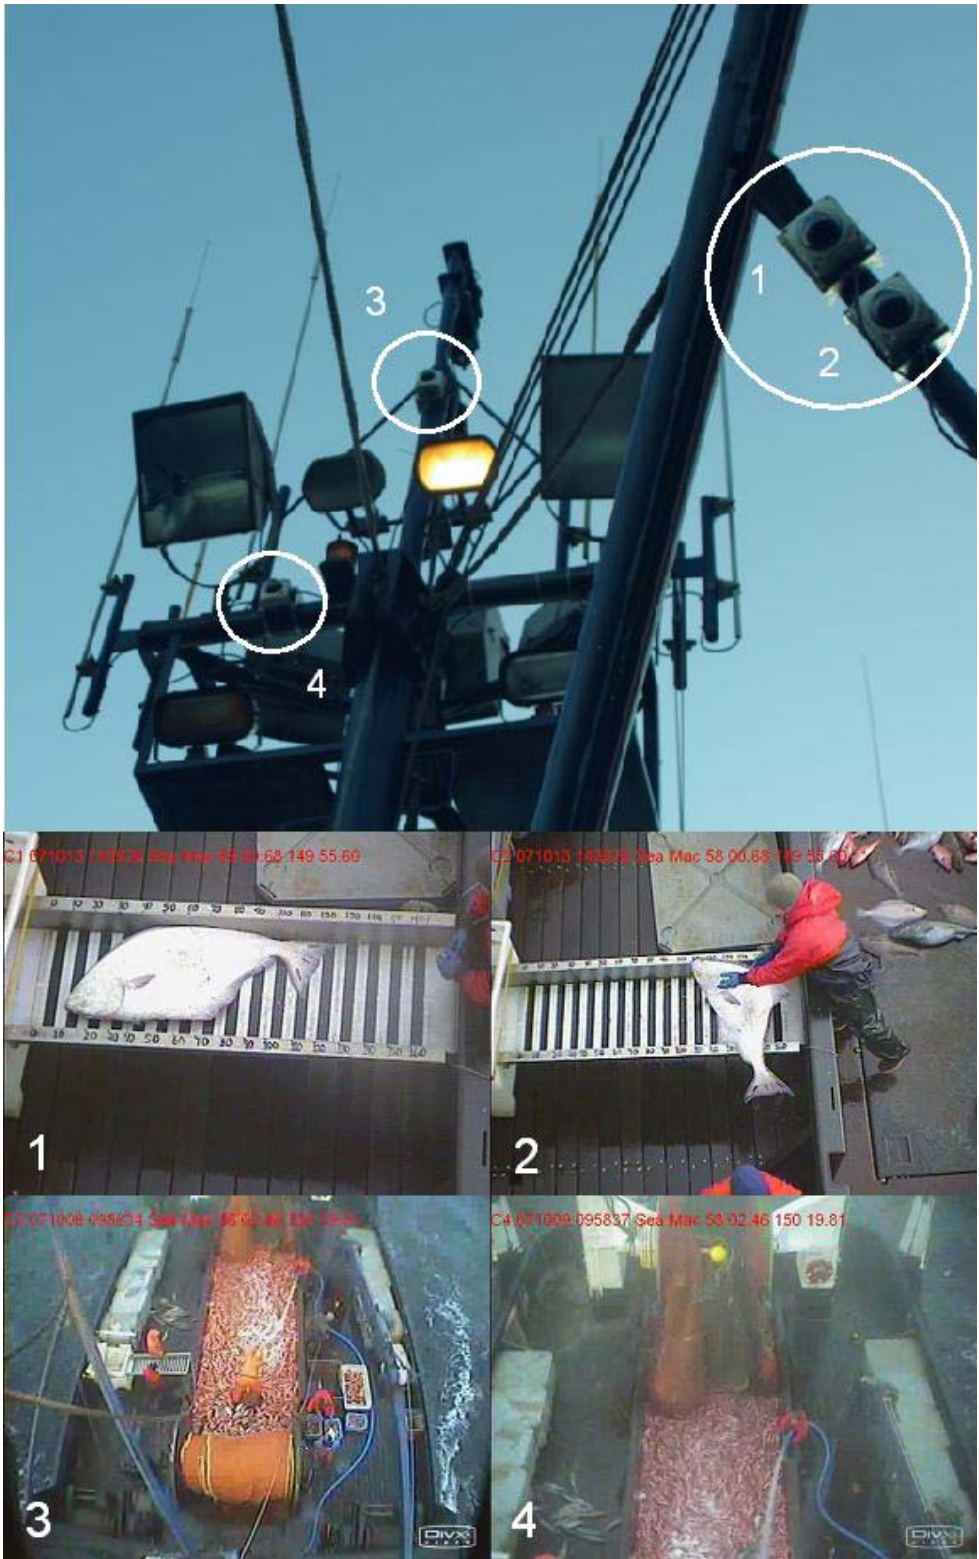
Figure A2 CCTV camera installations on three different fishing vessels. Each camera has a mounting bracket and stainless steel mounting straps.

Waterproof armoured dome cameras were used as they have been proven reliable in extreme environmental conditions on long-term deployments on fishing vessels. The camera is lightweight, compact and quickly attaches to the vessel's standing structure with a universal stainless steel mount and band straps. In general, three or four cameras were used to cover general fish and net handling activity and areas around the vessel.

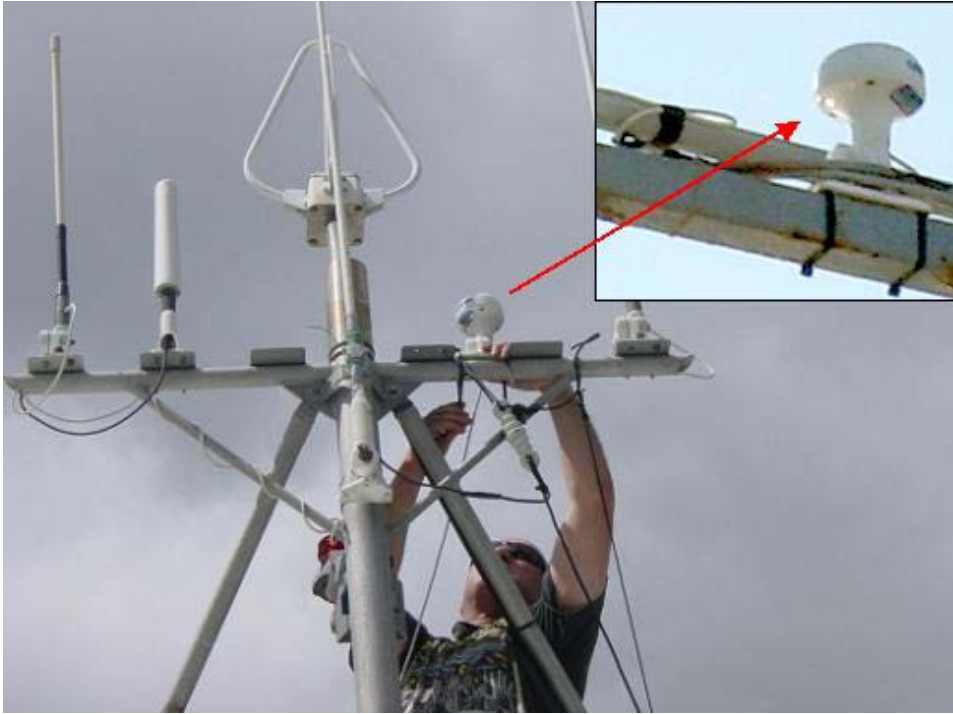
Figure A3. GPS receiver installed in the rigging of a vessel and a close up photograph of the mounted GPS.

An independent Garmin 17N GPS receiver is installed with the EM system. The GPS receiver and antenna are integrated into a single plastic dome that is wired directly to the control box, there is no attached display interface. The GPS receiver is fixed to mount on top of the wheelhouse away from other antennae and radars (Figure A3).

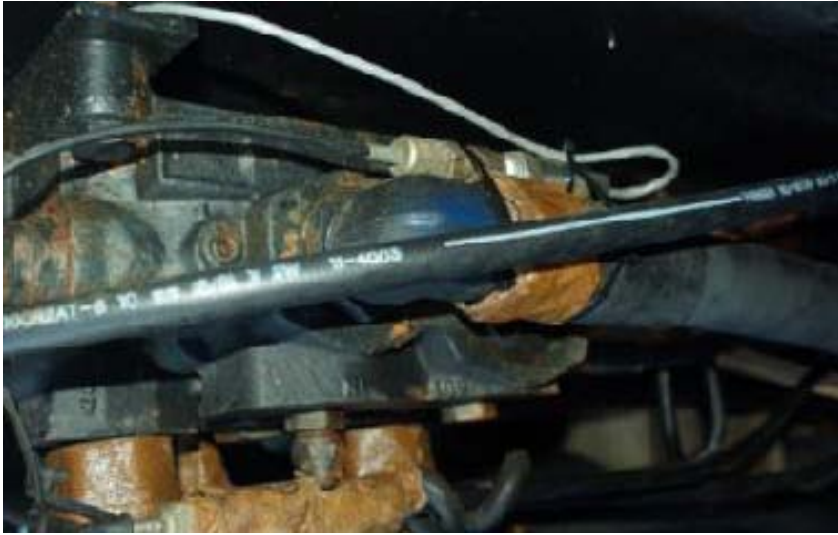
Figure A4 Hydraulic pressure transducer installed at trawl warp winch.

An electronic pressure transducer was attached to the hydraulic system (Figure A4) of each vessel to provide a record of fishing activity. The sensor has a 0 to 2500 psi range, high enough for most vessel hydraulic systems, and a 15,000 psi burst rating. The sensor is fitted into a ¼ inch pipe thread gauge port or tee fitting on the pressure side of the hauler circuit. An increase in system pressure signals the start of fishing operations such as longline retrieval. When pressure readings exceed a threshold that is established during system tests at dockside, the control box software turns the digital video recorder on to initiate video data collection.

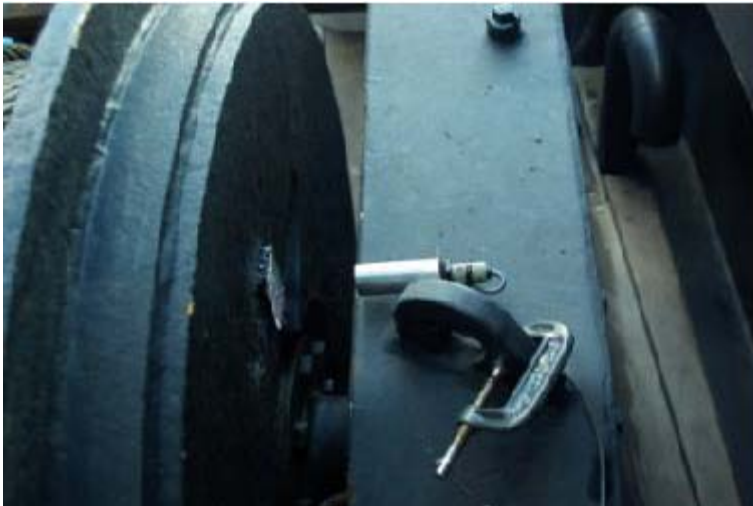
Figure A5. Drum rotation sensor mounted on trawl warp winch, showing optical sensor and reflective surface.

A photoelectric drum rotation sensor is usually mounted on either the warp winch or net drum of each vessel (Figure A5). The small waterproof sensor is aimed at a prismatic reflector mounted to the winch drum to record winch activity and act as a secondary video trigger.
